SciPan 4: PROGRAM DESCRIPTION AND TEST RESULTS

As part of the U.S. Department of Defense Explosives Safety Board (DDESB) Project ESKIMORE, the U.S. has conducted the fourth test in its SciPan test series, which consists of full-scale donor/acceptor trials examining debris generation and acceptor response. The SciPan 1 and 2 tests and results were reported at the 2004 DDESB Seminar. SciPan 3 was reported on at the 2006 DDESB Seminar. The overall SciPan program is described, with emphasis on the debris generation results from SciPan 4. This event, which was conducted in August 2008 at Naval Air Warfare Center, Weapons Division, China Lake, CA, was a 1,000 kg (2,205 lb) detonation of non-fragmenting munitions inside a typical reinforced concrete operating building. Results from this test including airblast effects, debris densities patterns, and fragmentation characteristics are presented. Comparisons of debris density as a function of azimuth and distance are made with analytical debris prediction models, as well as with traditional Quantity-Distance criteria.

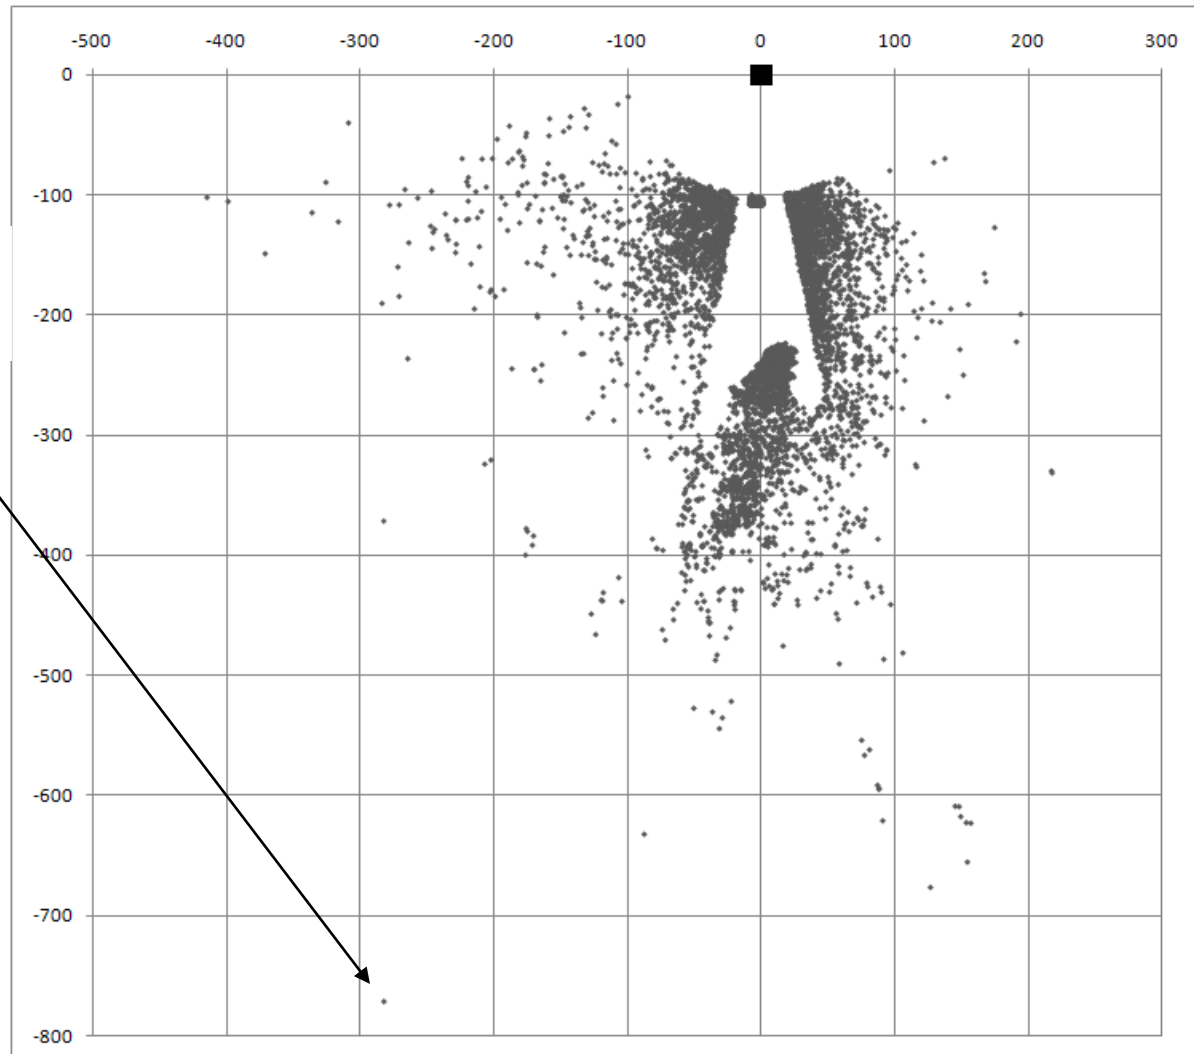
Debris Pattern: CMU Wall

Farthest piece found
at 821 meters

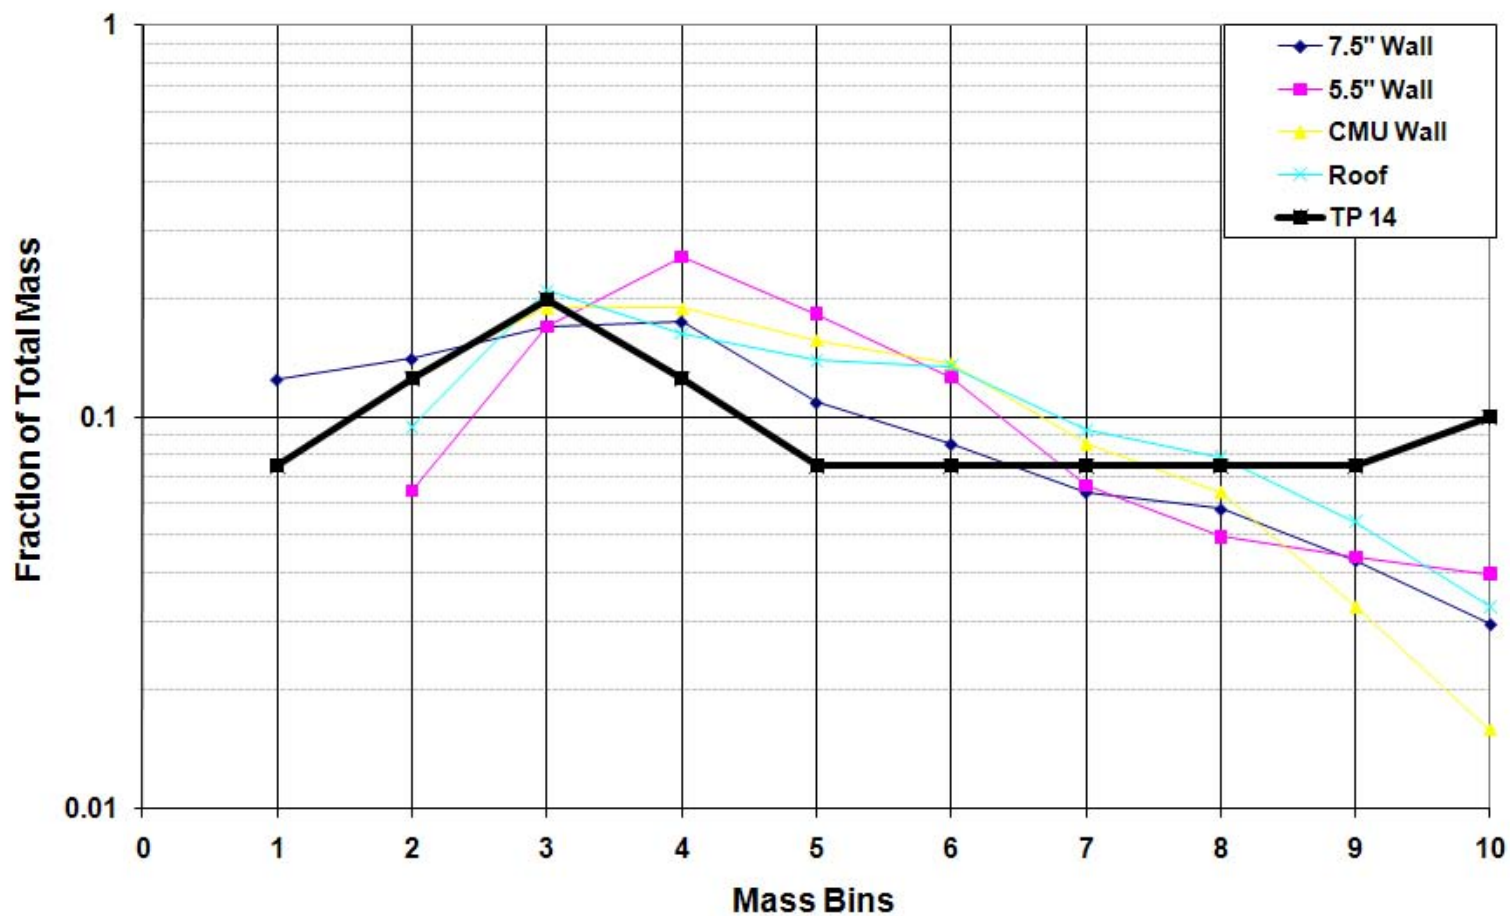
SciPan 4 Concrete Comparison

Mass Bin Comparison

While the contribution of all pieces smaller than Mass Bin 10 has been removed from the test data for this comparison, it should be noted that the Mass Bin distribution presented within TP 14 accounts for the entire mass of the donor structure, and thus all pieces of debris smaller than Mass Bin 10 are included in that Mass Bin. Due to this philosophical decision, the mass fraction and the total debris count fraction values of Mass Bin 10 for TP 14 presented in Tables 6 and 7 are artificially high. This should be taken into consideration prior to making any direct comparisons between the TP 14 values and the test data for this Mass Bin.

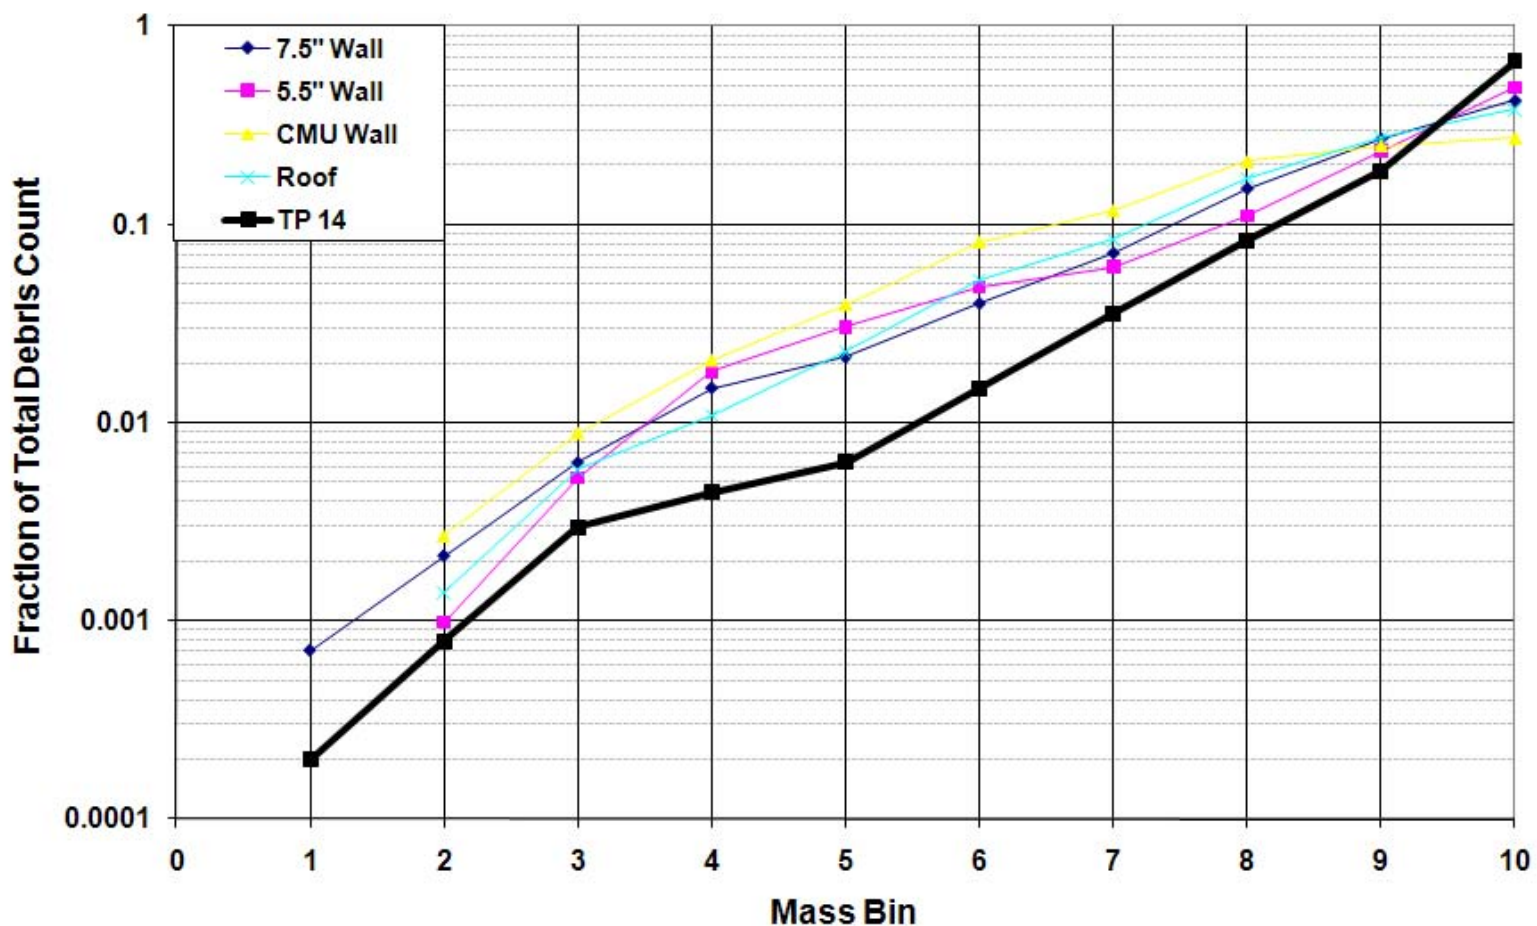
SciPan 4 Concrete Comparison

Mass Bins: Fraction of Total Debris Count

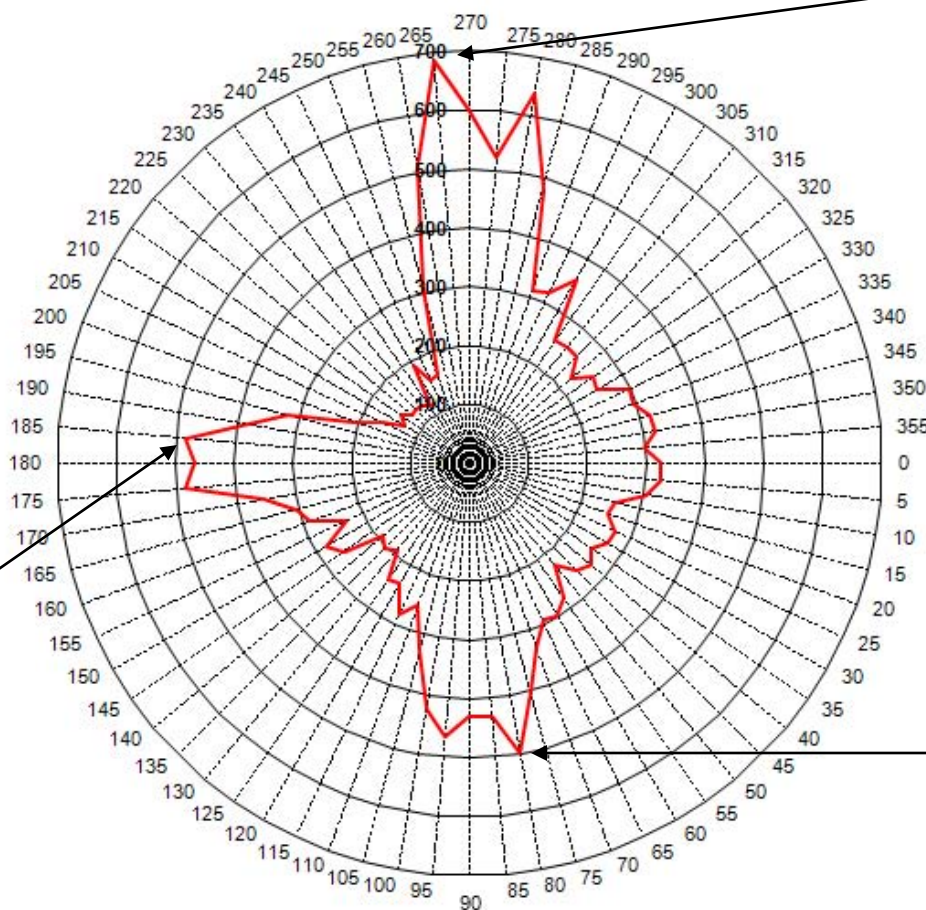
SciPan 4 PTN Debris IBD

5.5" R/C Wall
Debris IBD:
686 meters
(2,251 feet)

7.5" R/C Wall
Debris IBD:
486 meters
(1,594 feet)

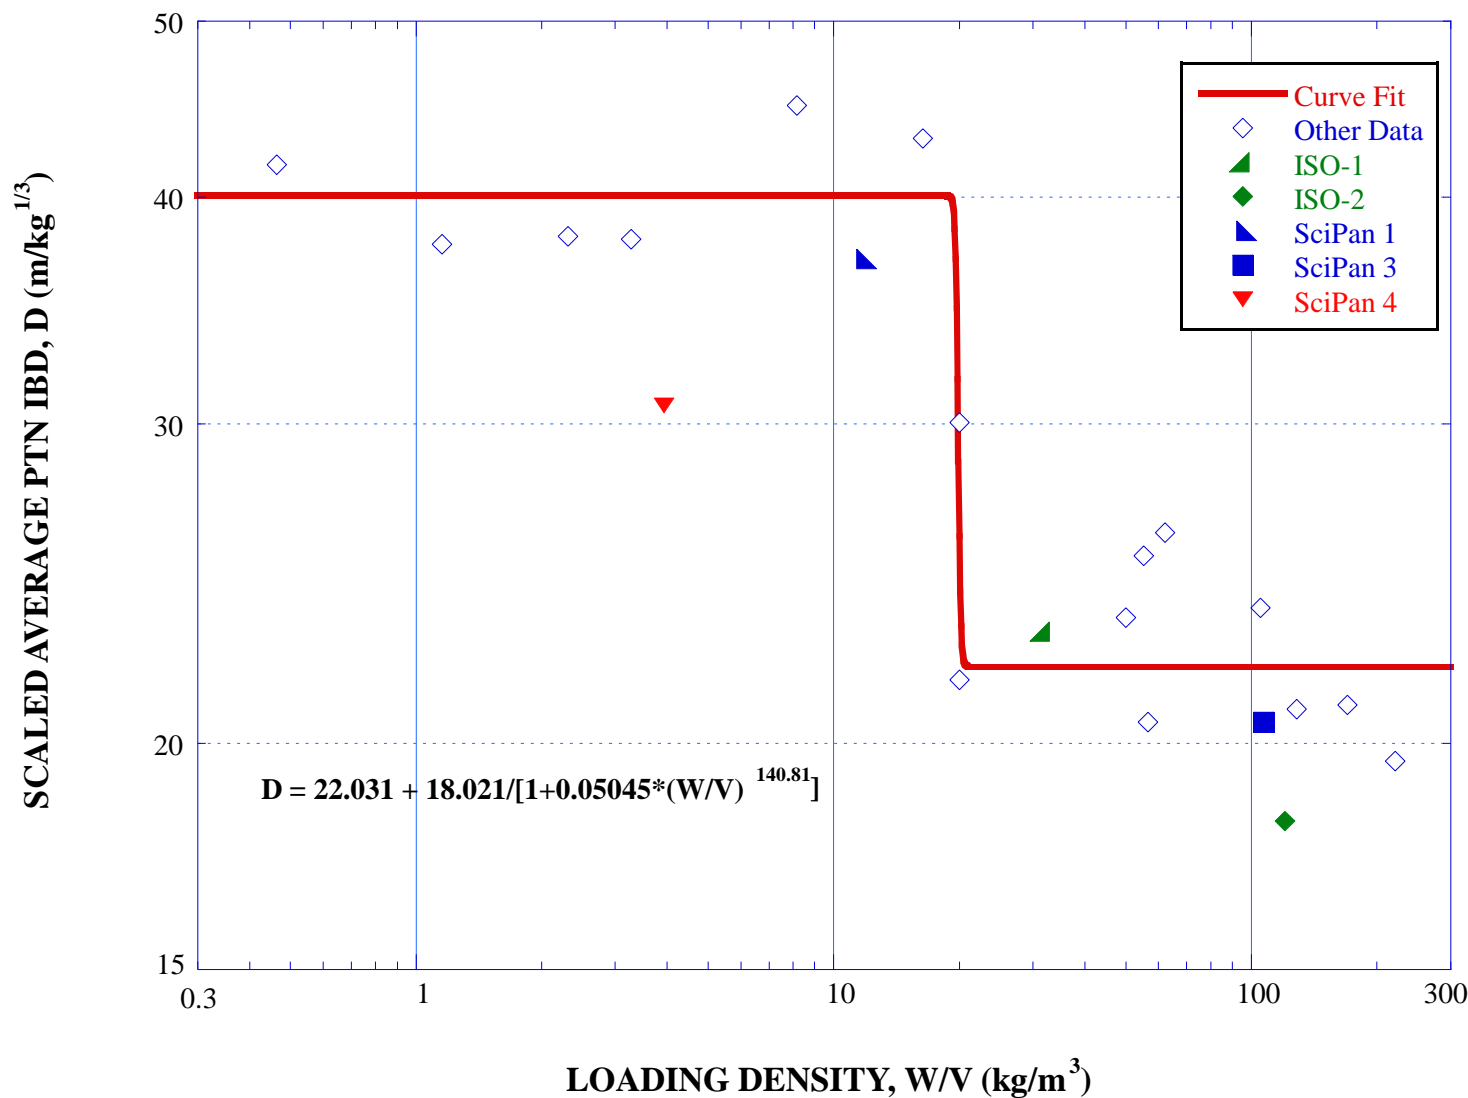
Scaled PTN Debris IBD Function

- When the SciPan 4 debris data are averaged over the full 360° of azimuth, a PTN debris IBD of 307 meters is obtained.
- It has been shown that the cube root of the PTN debris IBD has a high correlation with the loading density of the structure.
- Previous test data under Project ESKIMORE has reinforced this correlation
- The results of SciPan 4 are not consistent with this proposed relationship.
- Hazardous fragment definition used here differs from those assumptions used to generate the plot
- This discrepancy warrants examining past test data with low loading densities to explain the difference

Debris Inhabited Building Distance (IBD) is defined as the range at which the density of hazardous fragments falls below a value of 1 per 55.7 m². A hazardous fragment is defined as a fragment with an impact kinetic energy of at least 79 Joules.
